DOE/NV--1158

Post-Closure Inspection and
Monitoring Report for Corrective
Action Unit 110: Area 3 WMD
U-3ax/bl Crater,
Nevada Test Site, Nevada

For the Period July 2005-June 2006

August 2006

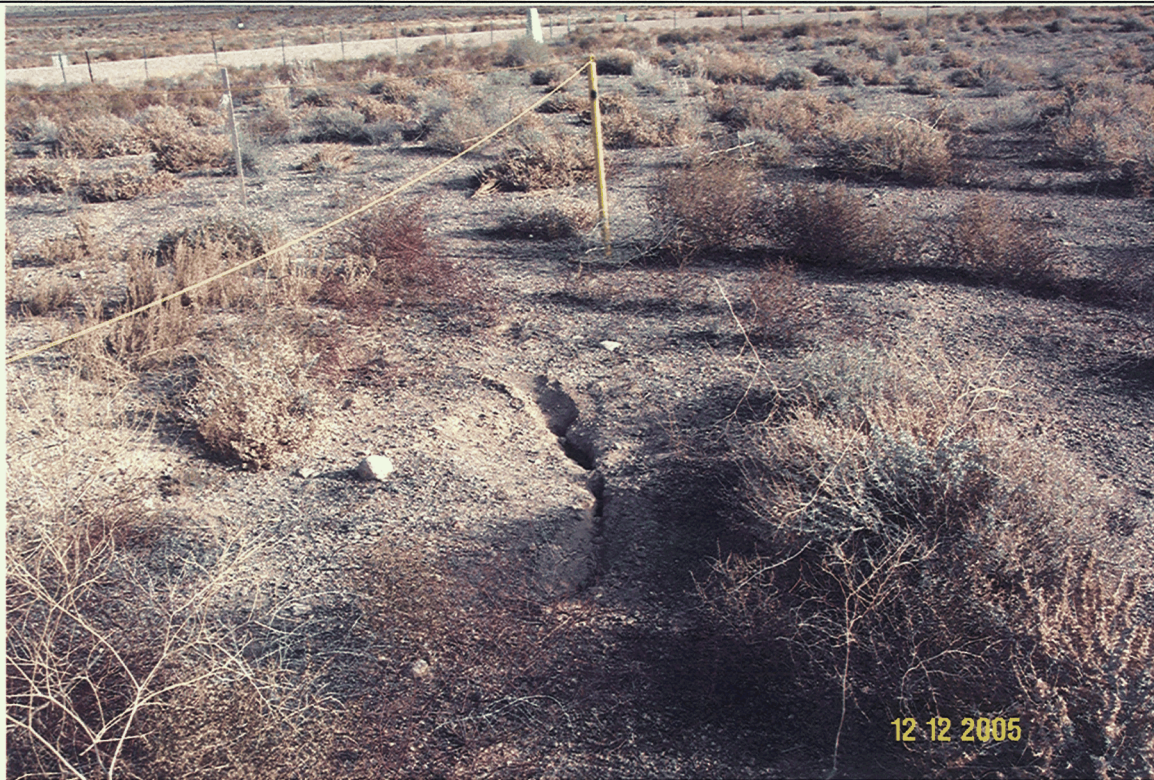
- Gate lock does not open.
- Three signs of subsidence were found. They are a 1 x 1.5 x 8-ft area found 10-ft to 12-ft north of the east TDR, a 2-in. x 18-in. x 8-ft area found on the east side where previous subsidence has been monitored, and a crack 10-ft to 12-ft long and 1-in. wide that has been previously monitored.
- The condition of warning signs and fencing was good.

9. Subsidence crack along eastside of the cover.

During the December 12, 2005, inspection, three areas of settling on the cover (one area 10-ft north of the east TDR, one on the east side, and one in the northeast) exceeded the settling compliance criterion. The area along the east side of the cover had been repaired on several previous occasions. The three areas were repaired over the period of February 6-7, 2006. A portable, gas-powered tamper was used to compact the cracks in the cover. The first two areas were backfilled with clean, native soil using wheelbarrows and shovels, and then compacted using the tamper. Because the crack system on the third area was much larger and deeper than anticipated, work on the third area was ceased for the first day. After an engineer reviewed and approved proceeding with work, the third area work commenced again on the second day. This area was repaired following the same procedure as for the other cracks. Field notes for this repair are included in Appendix A.

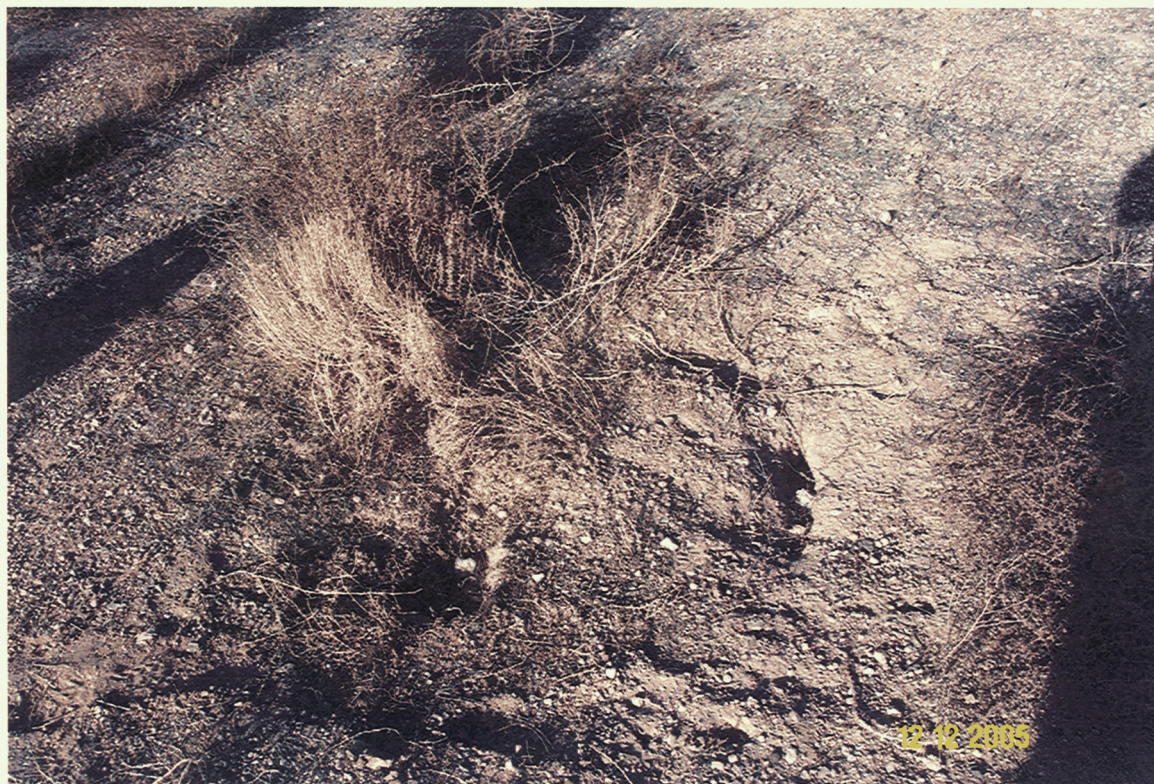
10. Circular subsidence crack on the cover.

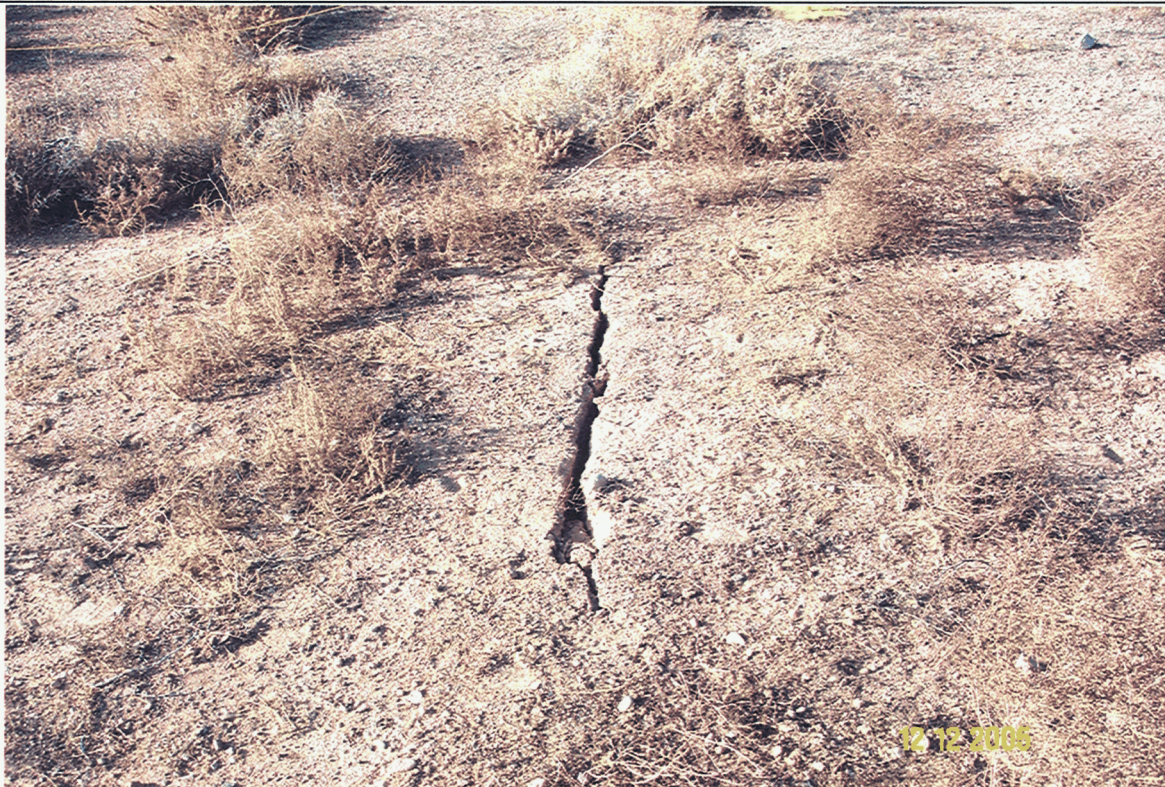
11. Reoccurring subsidence crack on the cover.

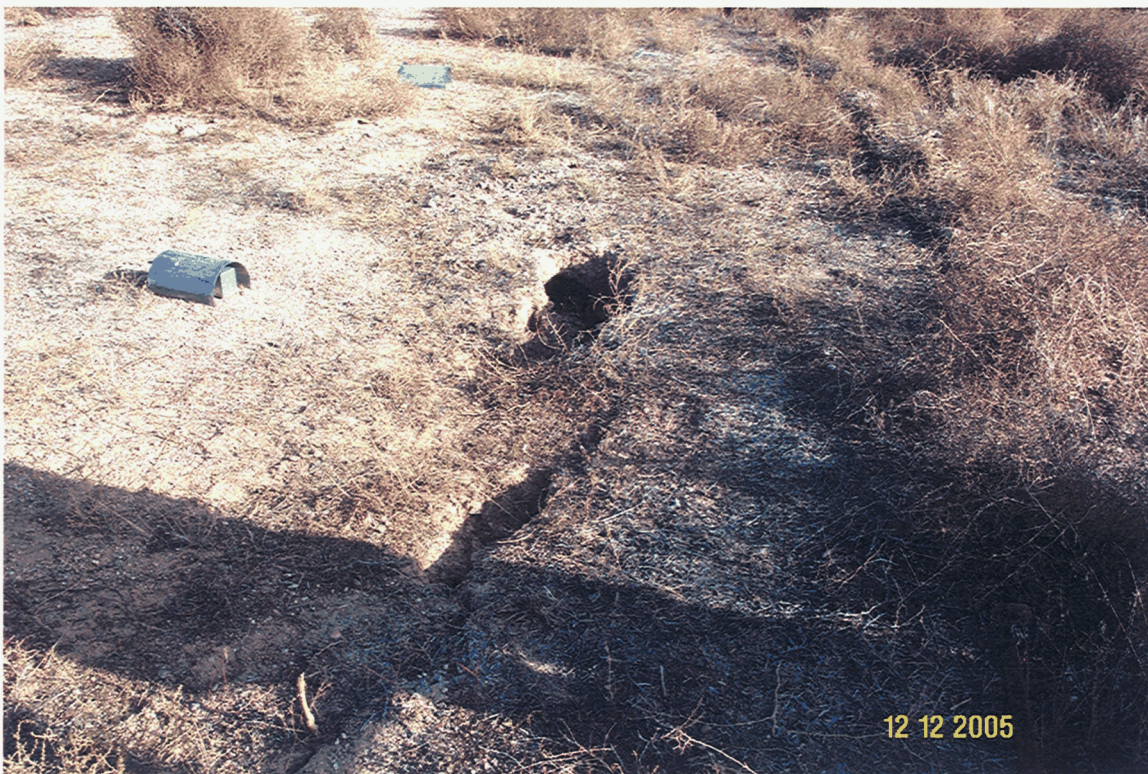
12. Small animal burrow on a subsidence crack.

Because of the large number of small animal burrows found on the cover and fence line during the March 23, 2006, site inspection, trapping and relocating small mammals on the cover was undertaken. This activity began the week of April 18-20, 2006, during which a total of 160 deer mice and kangaroo rats were trapped and relocated from the cover.

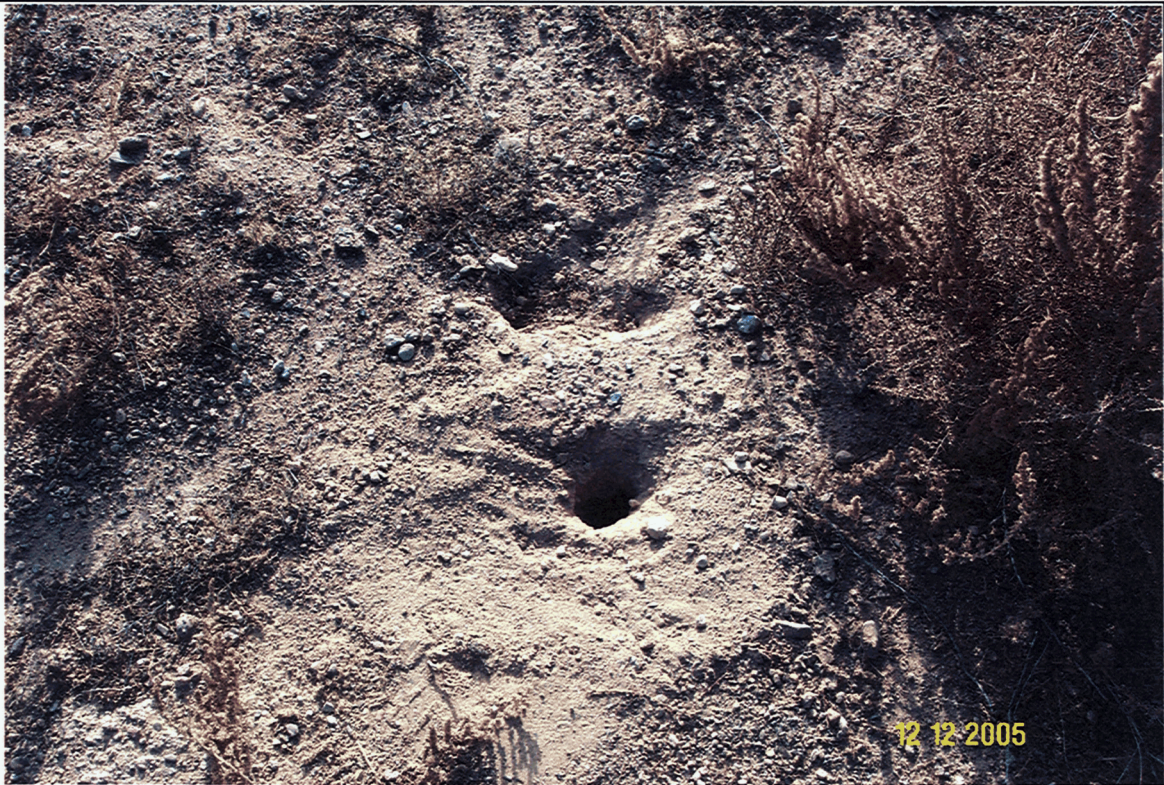
13. Small animal burrow on the cover.

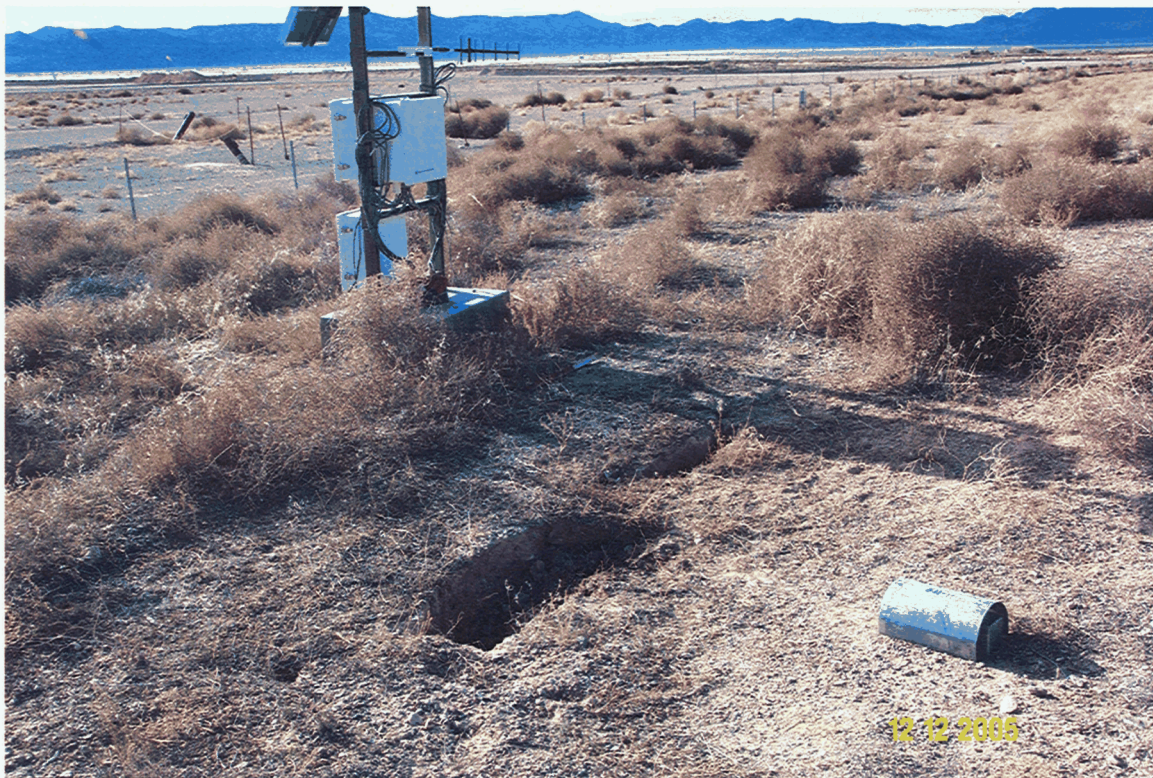
14. Small animal burrow behind the west TDR.
